Batey-Bould Off-Road Motorcycle Trail System Assessment

Newport Ranger District

Colville National Forest

September 2016

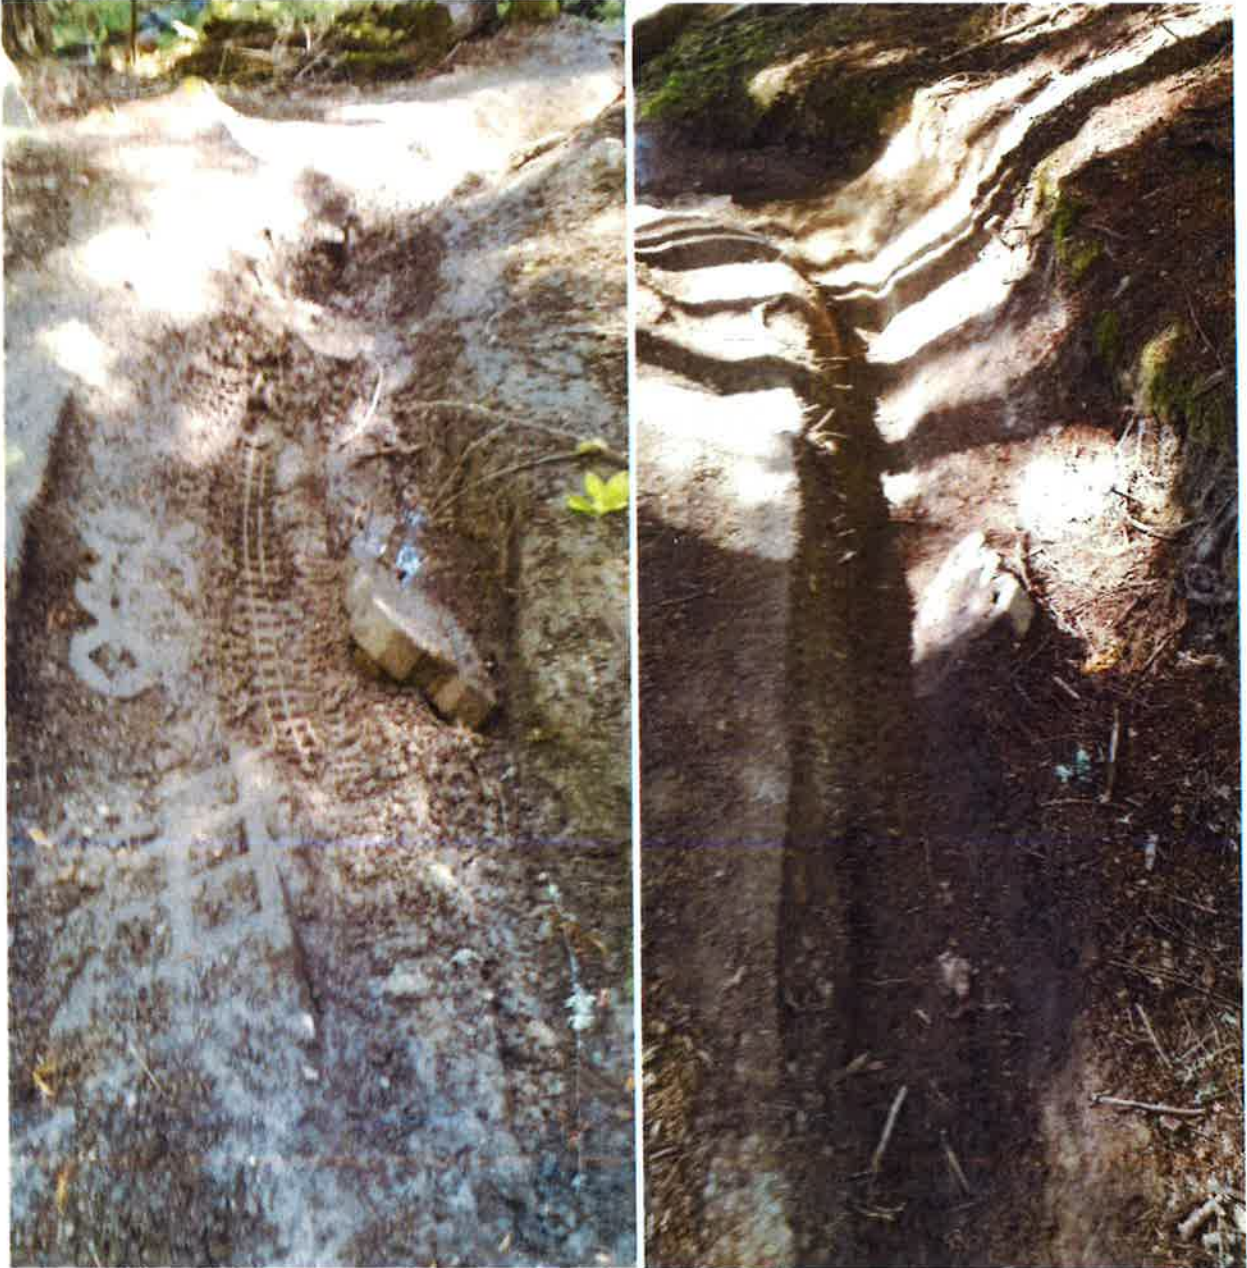
The following two photos show deeply incised sections of MC306 which were assessed for safety concerns. The paver blocks have been installed to harden the trail, but this has not been successful because paver blocks “float” and move around in the mud if not installed “wall to wall” in the rut. Importing 3” minus crushed aggregate (not bar run, it needs to be angular rock) would help harden the trail more successfully. The exposed paver blocks should be removed, but *they do not present an unreasonable risk* compared to other challenges on similar trails.

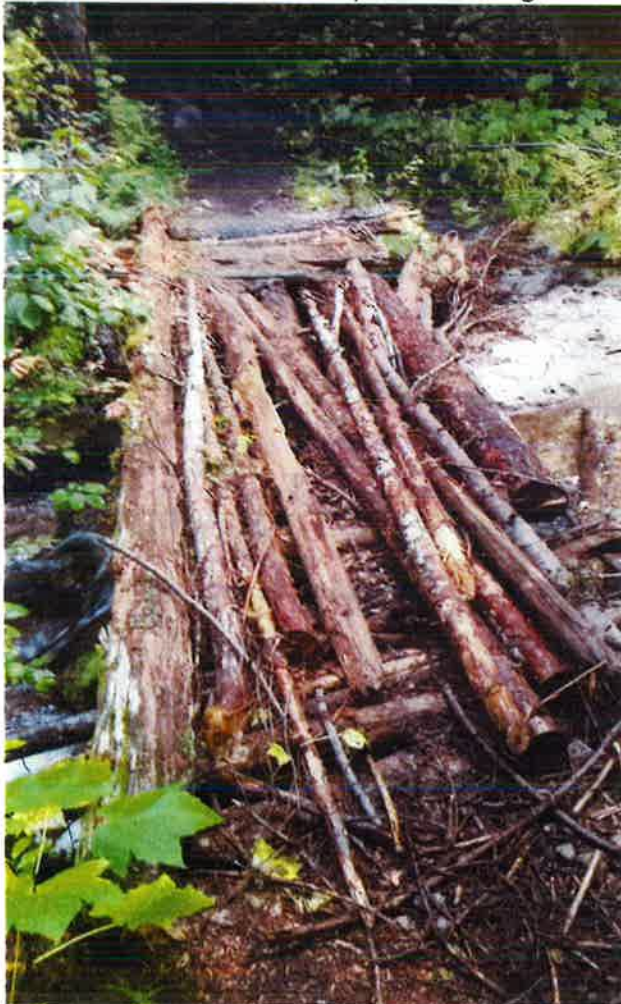
Tacoma Creek “Bridge” 9/20/2016

Tacoma Creek Bridge (Survey #25)

Condition: “0” rating. **Failed**, out of service. Almost all of the original structural elements are missing. The original 16-18’ bridge has been “replaced” by tree tops and logs that allow a user to cross with significant risk of falling through the logs.

Recommendation: This trail bridge should be closed to the public and, if possible, a reroute provided to reduce the temptation to use the structure. There is suitable material on site to use for stringers and an Alaskan saw-milled deck to replace this bridge in-kind.

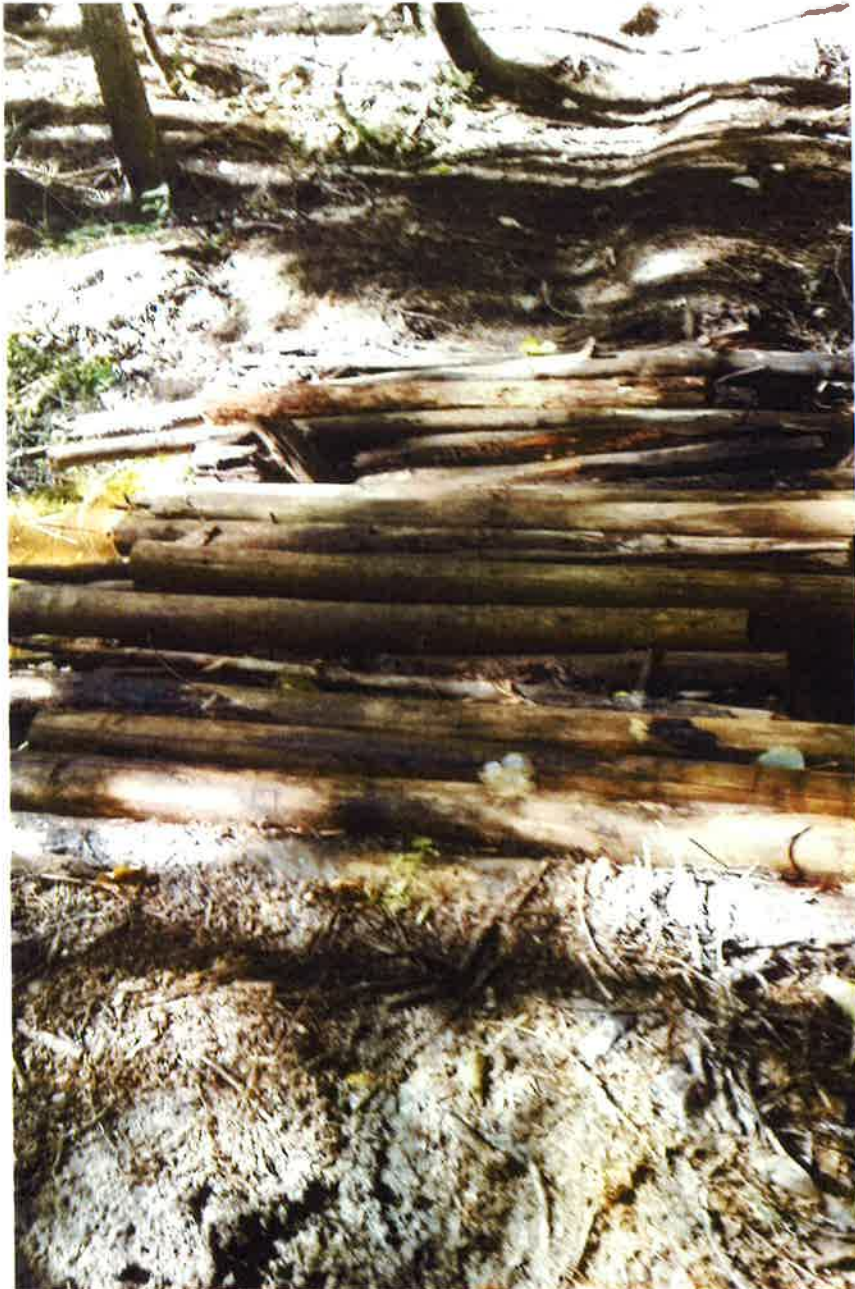
Condition: "0" rating. **Failed**, out of service. Most of the structural elements are missing. Those that remain have exposed spikes and rebar protruding such that they could injure a trail user if they slipped while crossing the puncheon.

User-created deck, Spike Puncheon, 9/20/2016

Recommendation: Remove the puncheon. Resource damage will likely result from this action, but it should be minimal if the puncheon can be replaced with a 24" culvert or a turnpike with several 6" pipes within one season. Even when "dry" the deck (pictured) is very slippery and could easily cause an accident.

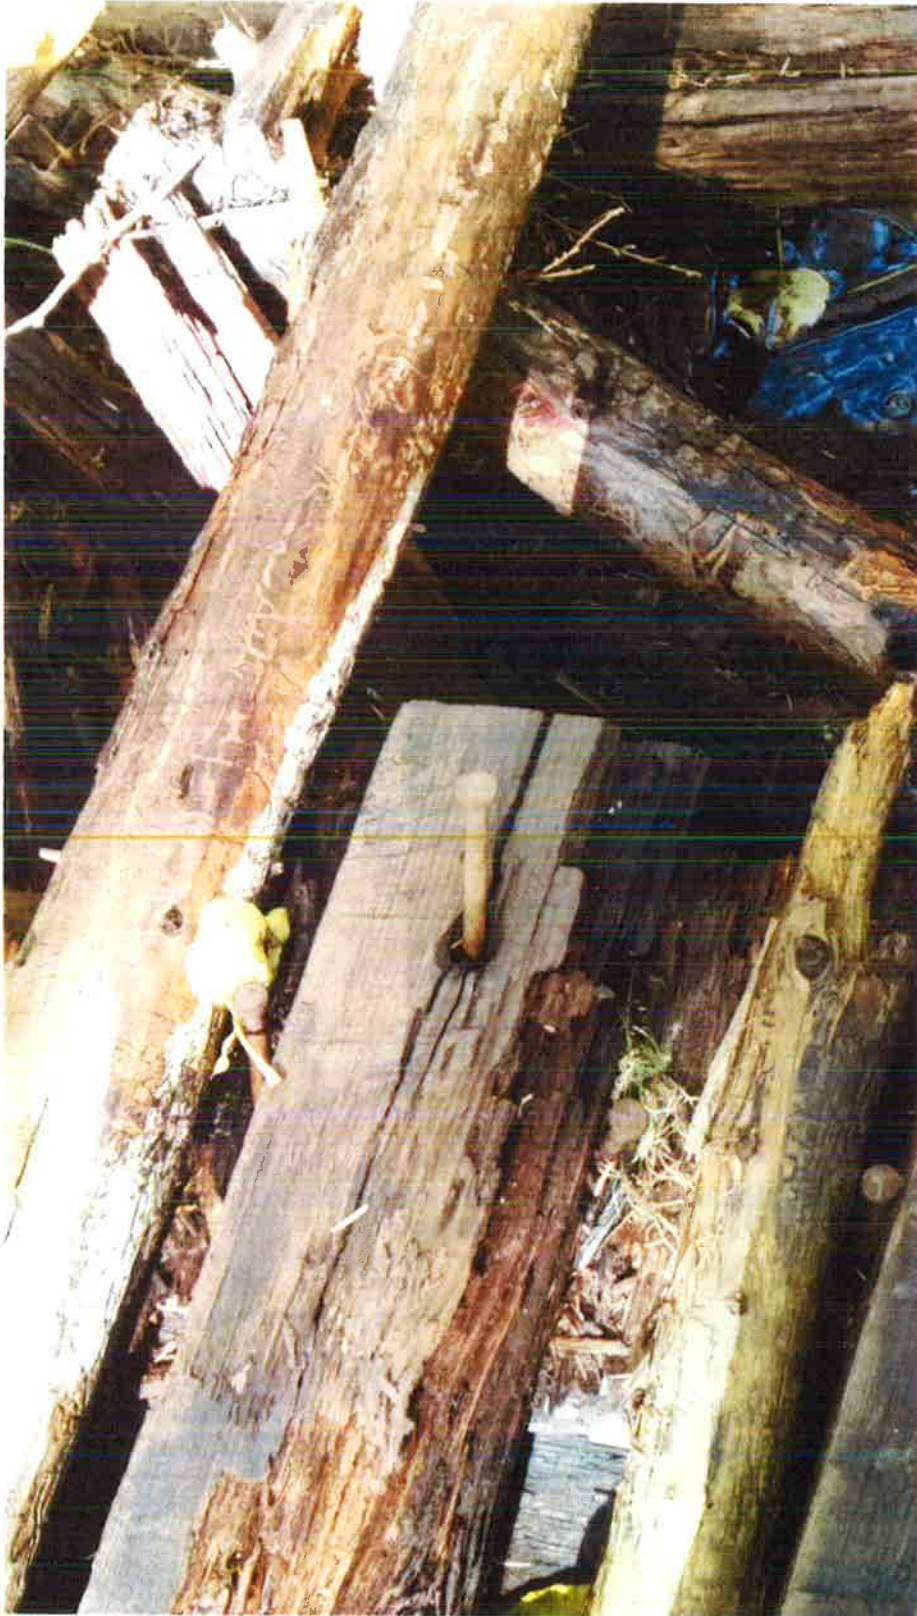
Spike Puncheon, 9/20/16

Spike Puncheon (Survey #22)

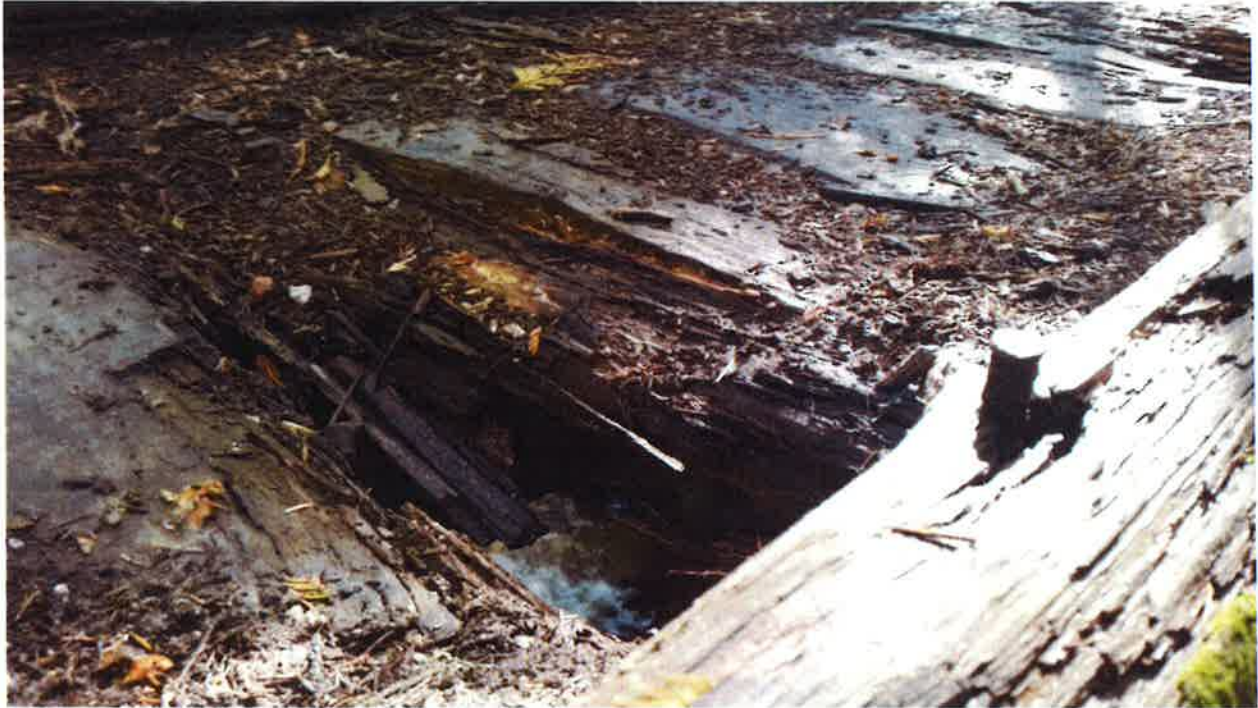
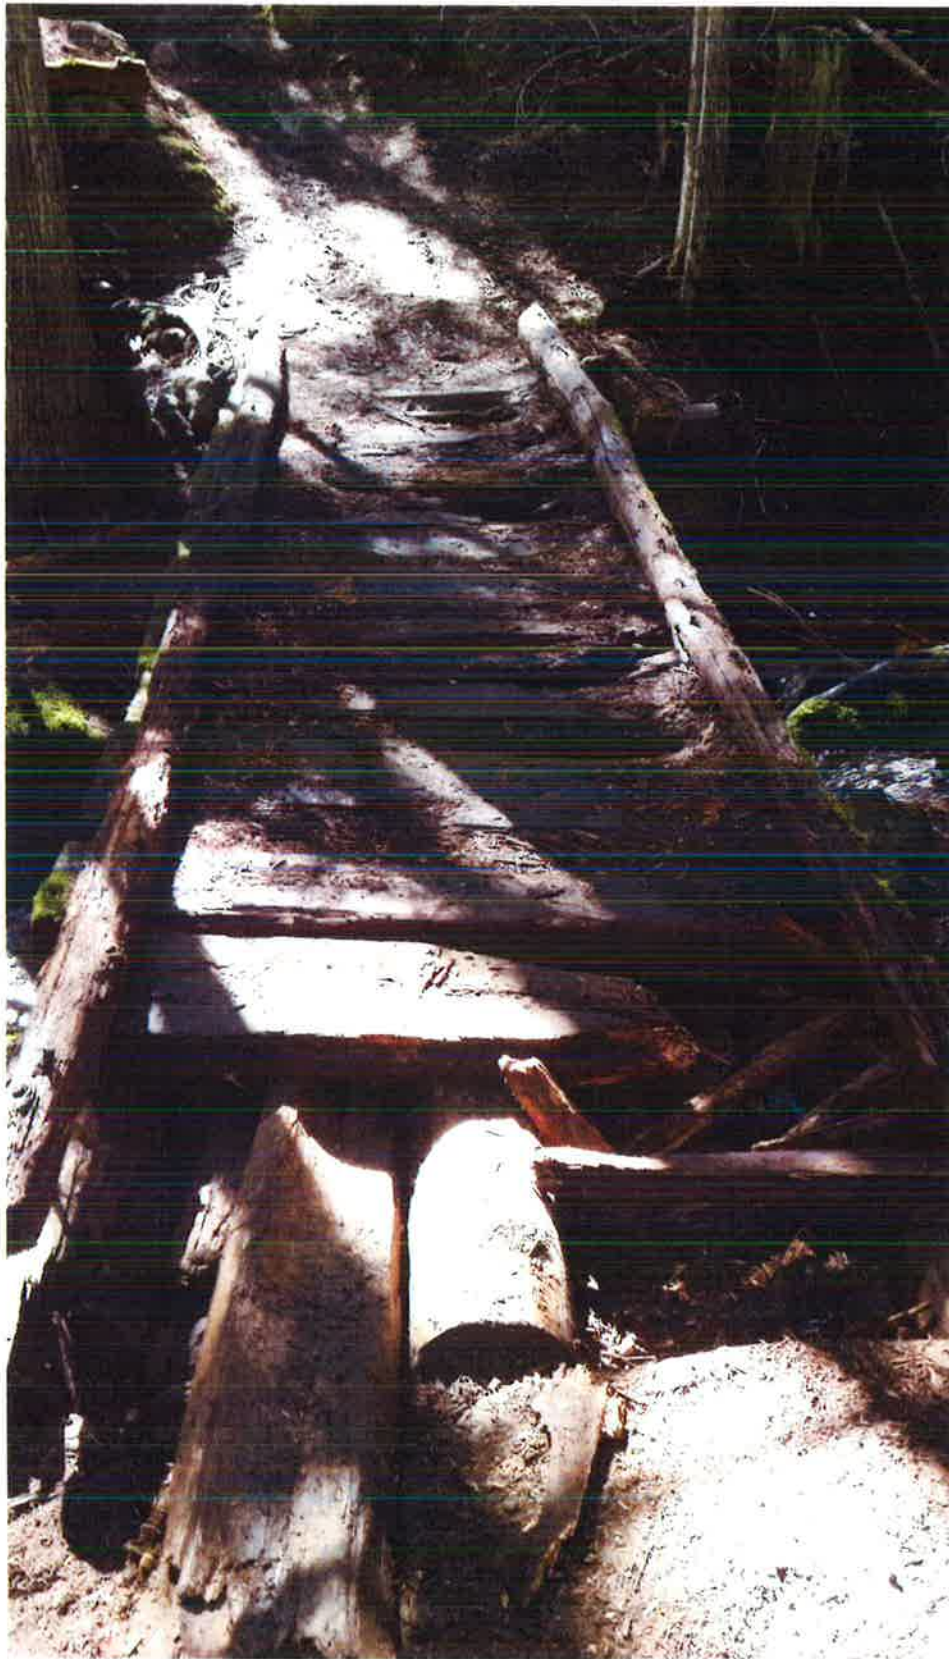
Bad Bridge (Survey #13)

Condition: "1" rating, **imminent** failure, due to sag, advanced rot in structural members and exposed hardware.

Recommendation: Hammer in, or cut off, exposed spikes and rebar, monitor monthly and replace as soon as possible. This bridge might be put back into light service by "bridging over" the current deck with 4"x6" lumber. The bridge is 20' long and if an engineer concurs, bridging the deck will safely hold user traffic, but *will not* meet the snow load rating for the area.

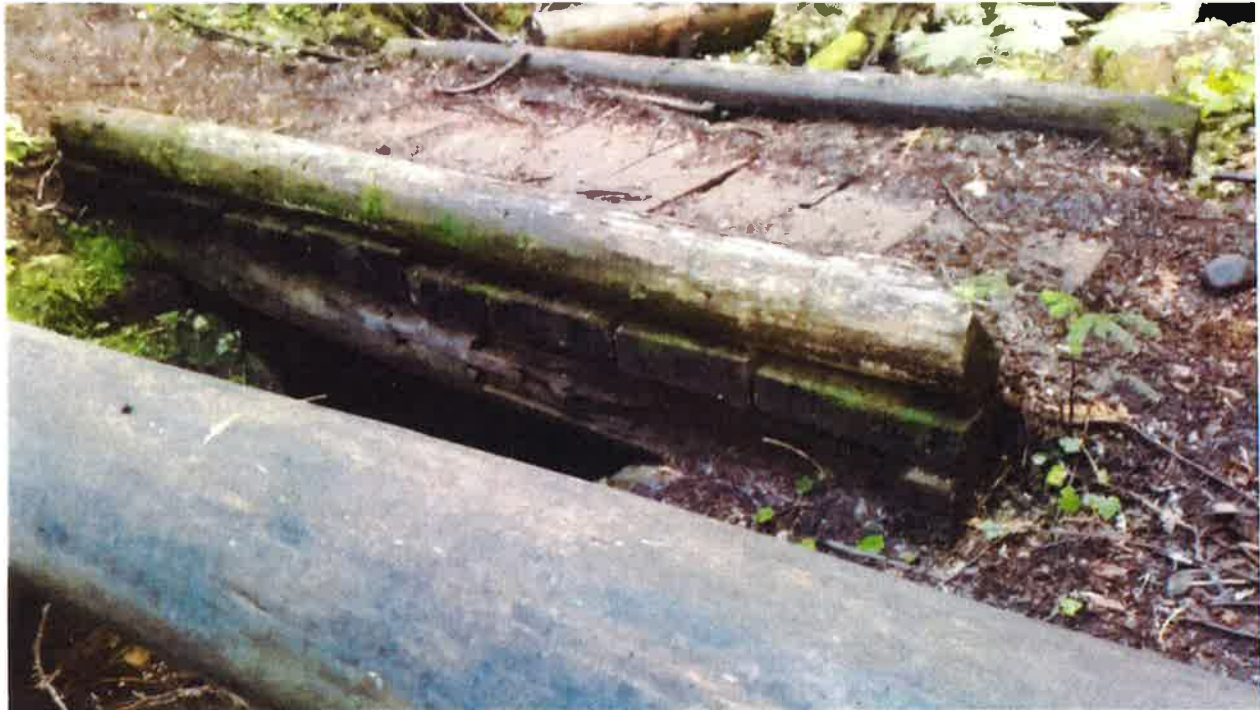
Condition: "3" rating. **Serious** condition, due to advanced section rot.

8' Bridge, 9/20/16. Notice the stringer in contact with the ground. It should be placed on a larger mudsill to prevent premature decay.

Recommendation: Monitor monthly and replace as soon as possible. Due to the large stringer section loss, this bridge gets a "serious" condition rating, but it has three 14" stringers, so it is not likely to fail catastrophically under a user's weight.

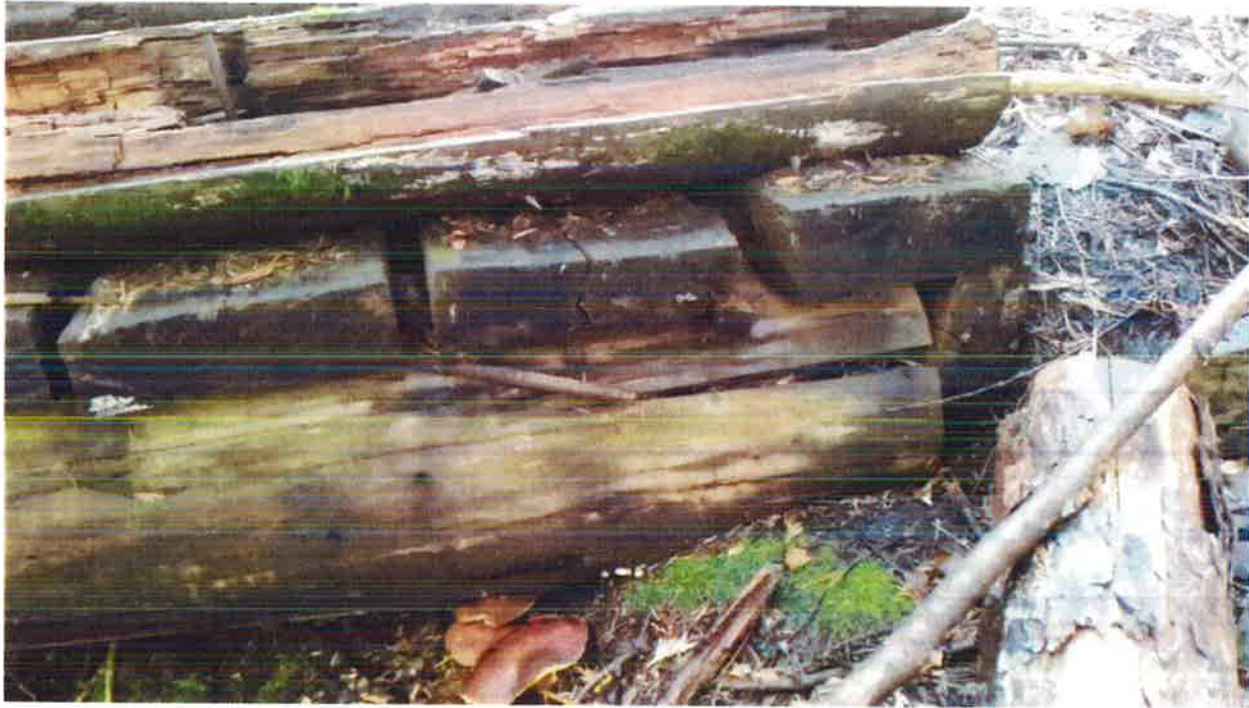
Condition: "4" rating, **poor** condition due to localized stringer failure and sag.

Localized failure. Larger mudsills would prevent these stringers from contacting the ground and rotting prematurely.

Recommendation: Since there are only two stringers for this bridge, a stringer failure is significant. The bridge should be monitored monthly and replaced as soon as possible. This bridge could be replaced in 1-2 days with on-site materials. Exposed hardware should be hammered in.

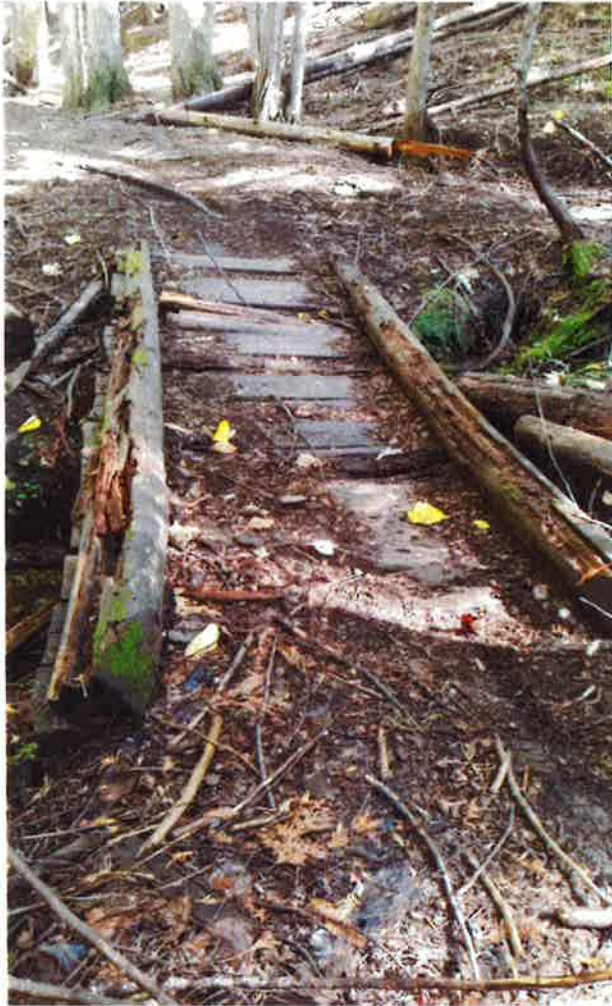
12' Bridge, 9/20/16. Deck is worn and broken, but substructure is relatively solid.

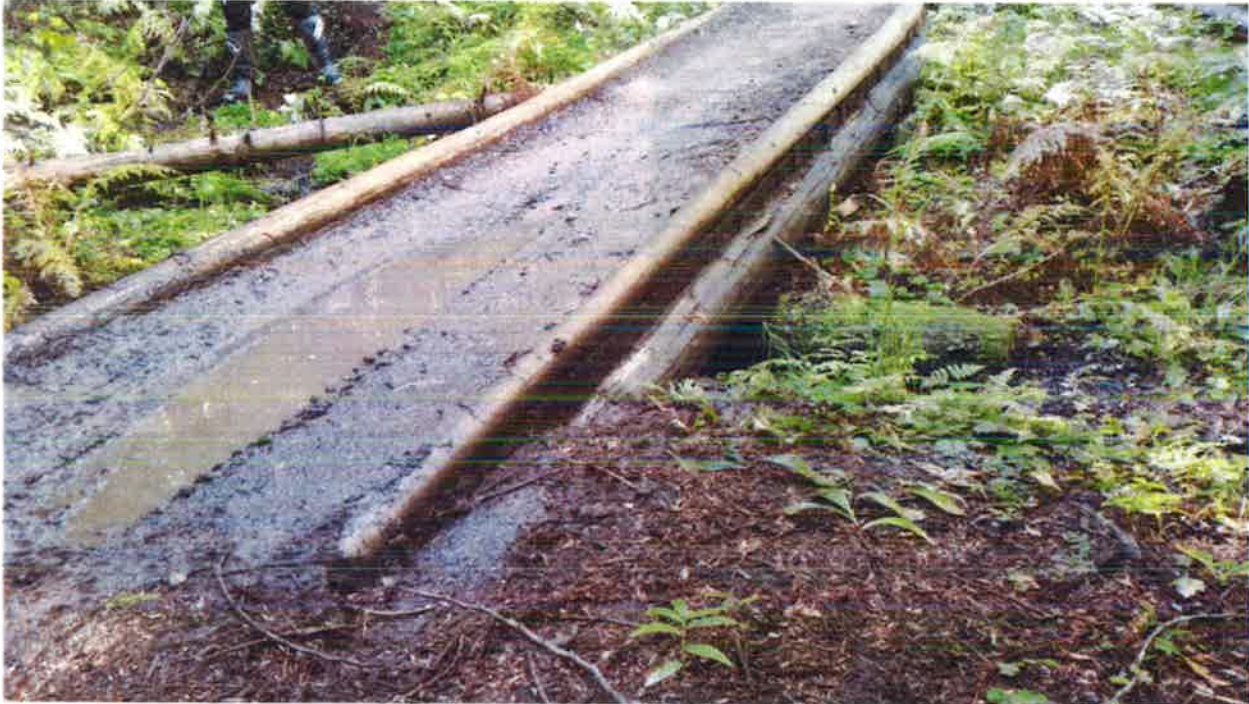
For the purposes of this report, we are concerned only with the sustainability of the trail, not the surrounding natural resources. Generally speaking, those resources are outside the scope of this report. That being said, any recommendations to improve trail sustainability will also likely improve soil and water quality. As an example, the photo below shows a good location for a puncheon with poor execution. The stringers are touching the mud and the whole feature is too low and won't drain. This puncheon collects water and holds it for days after a rain. When people ride across this feature, mud is thrown into the creek on both sides.

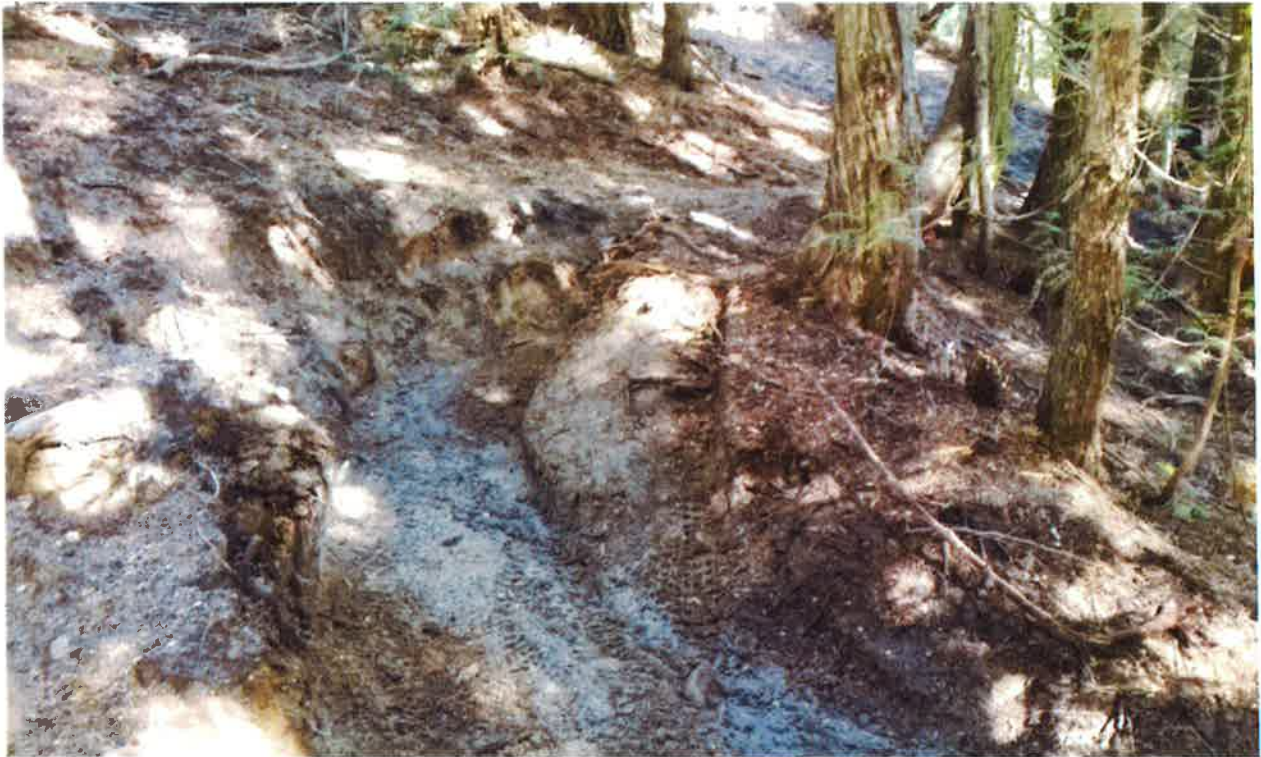
The turn shown above is entirely user-created in very poor soil. The constructed turn is 60 feet away to the left of the current turn. Erosion under paver blocks made them unstable and likely cause the users to avoid them. This turn is in a good location, with an appropriate side slope angle, but was poorly constructed without any inslope to allow cornering under power without lateral wheel slip.

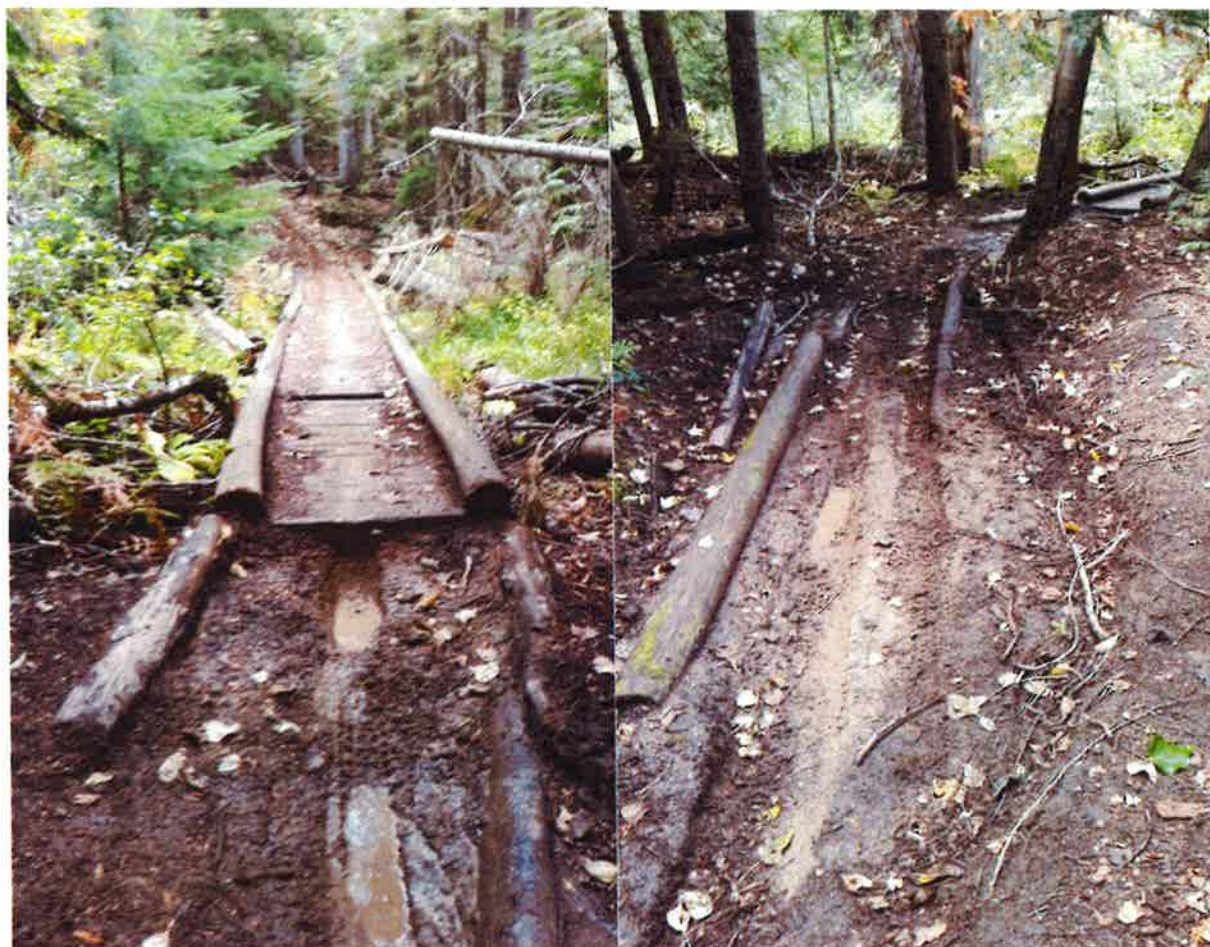
MC310 can only be reached by road or by a “more difficult” trail and therefore should not be rated as “easier”. In its current condition, MC310 should be rated as “more difficult” if it is kept in the system. It is recommended however, that MC310 be dropped from the system and officially closed. About one-third of the trail is laid out through a large, flat, marshy area that cannot be drained well. The quality of the trail is poor and there are no viewpoints or other interesting features to justify the high maintenance it will require to keep it to standard.

Two photos below illustrate the flat, marshy nature of MC310.

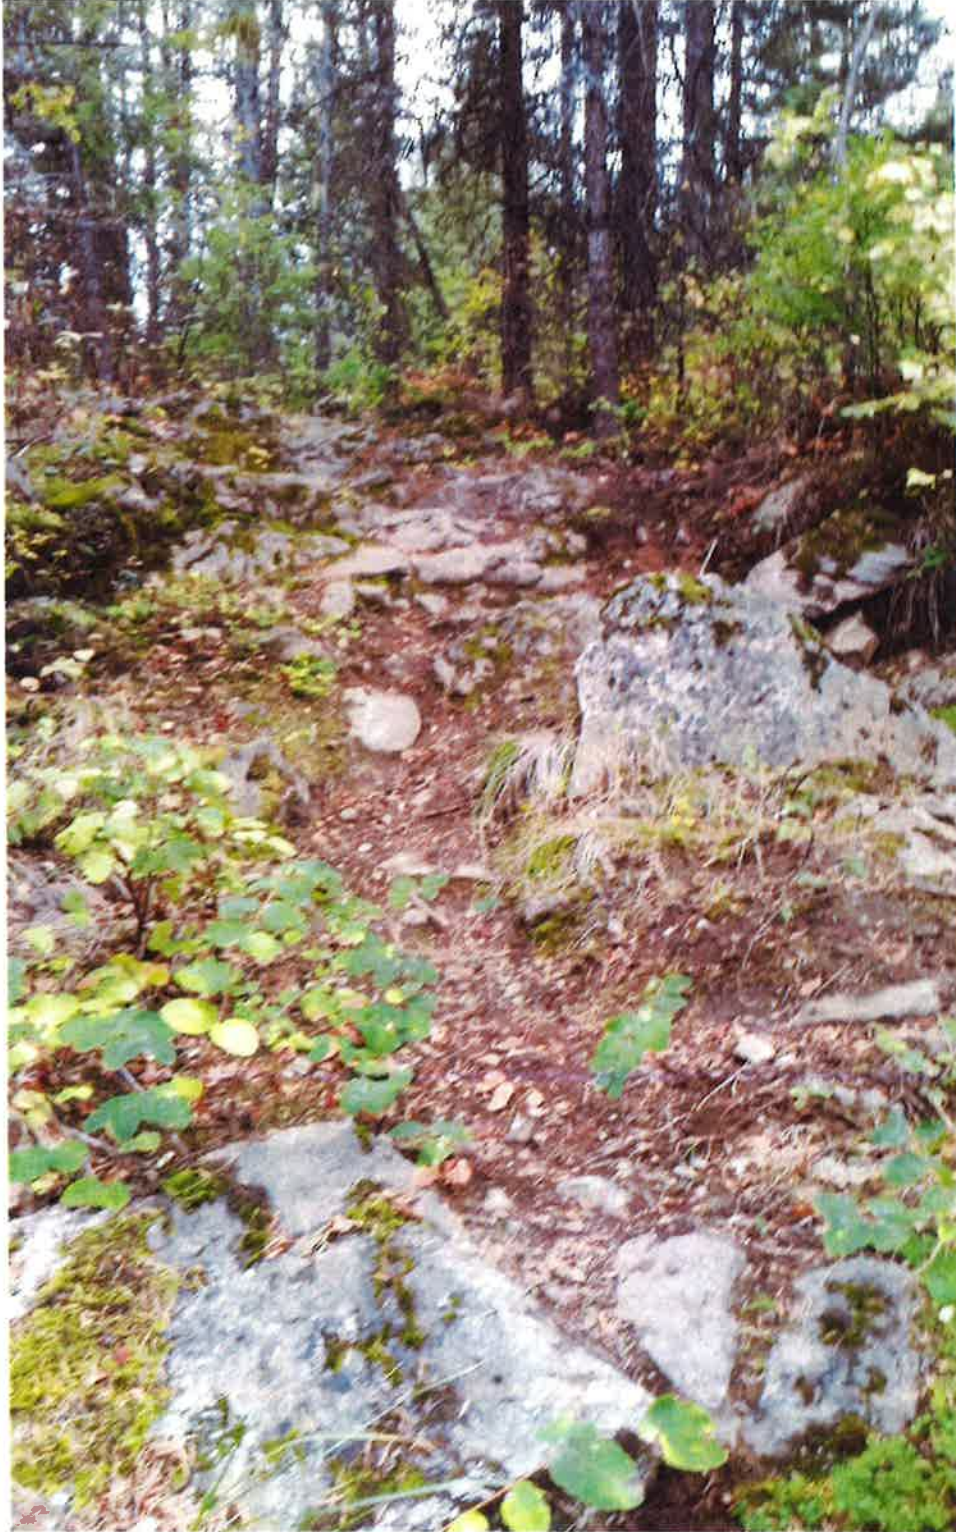
A steep, challenging section on the “most difficult” MC306 option. The trail goes up the middle and turns slight left above the rocks. The rocky area climbs at 80-100%.

Challenging, but not risky to a prepared rider.

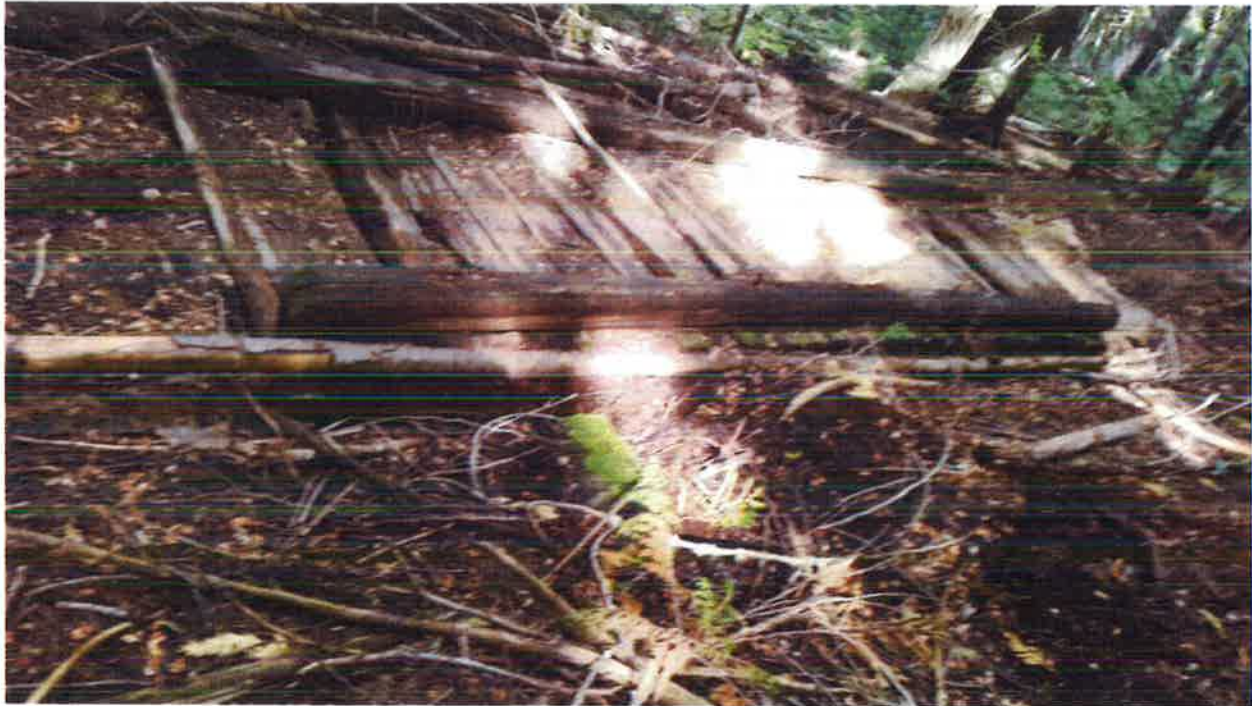
The following photo shows one of three unnecessary puncheons on MC311. Stream flow is low enough for a turnpike instead of puncheon which will last longer and are cheaper to replace.
