Batey-Bould Off-Road Motorcycle Trail System Assessment

Newport Ranger District

Colville National Forest

September 2016

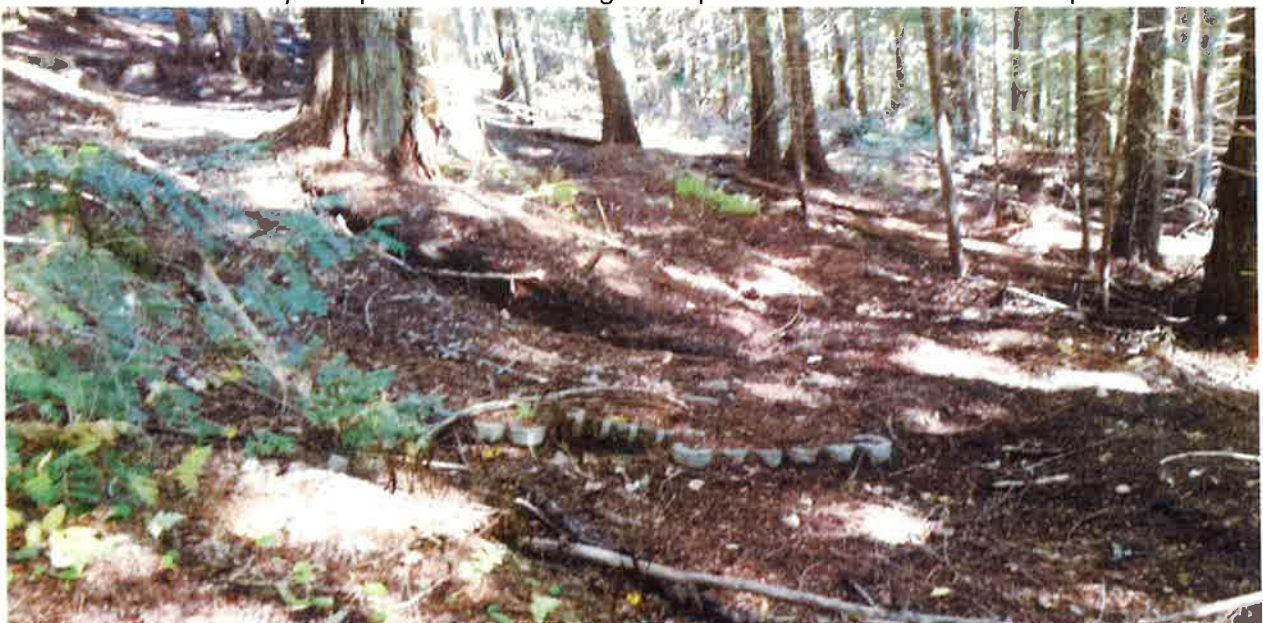
The turn shown above is entirely user-created in very poor soil. The constructed turn is 60 feet away to the left of the current turn. Erosion under paver blocks made them unstable and likely cause the users to avoid them. This turn is in a good location, with an appropriate side slope angle, but was poorly constructed without any inslope to allow cornering under power without lateral wheel slip.
